Manhole Inspection Summary

Manhole # S71Q__008MH

Insp Date: **4/15/08 8:30 AM**

Location Address: **6724 Bessemer Ave.**

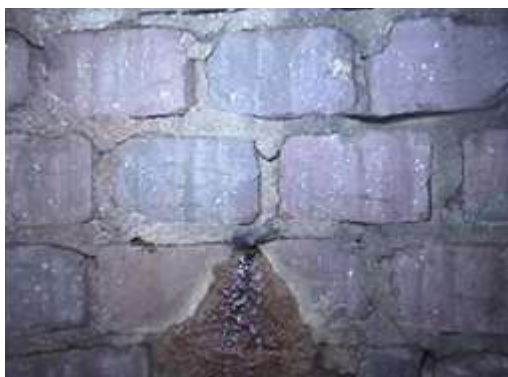
Defect 2

Infiltration: ☐ None ☐ Joint ☐ Cracks ☐ Mortar ☐ Roots ☒ **Wall**

weeper infiltration on barrel wall

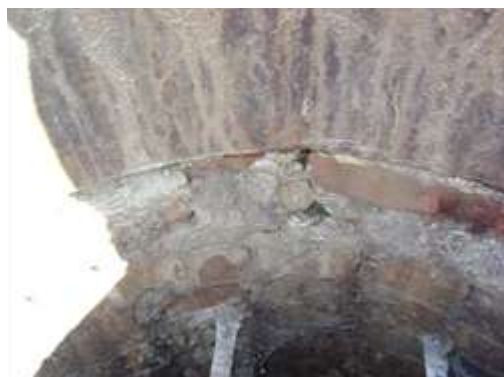
Defect 1

cracks in mortar at frame seal

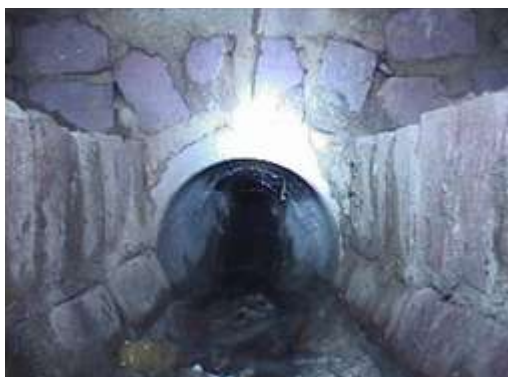
Defect 3

cracked pipe seal 10:00-12:00 outgoing
120'clock

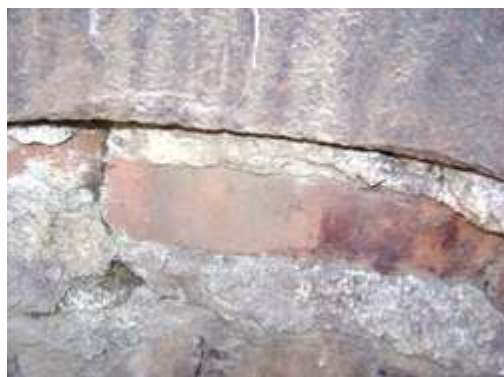
Defect 4

Condition: ☐ Sound ☐ Cracked ☐ Root Intrusion ☒ **Loose Brick** ☒ **Deteriorated**

cracked mortar at frame adjustment

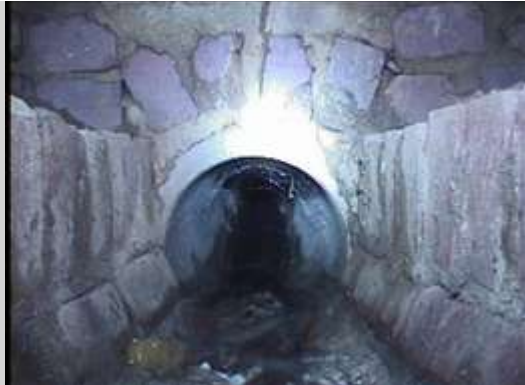
12 O'Clock Outflow

Pipe Height: **8.4** (in.) Rod and Bar (Angled)
Pipe Material: **Clay** ☐ Pipe Lined
Invert Depth: **12.25** (ft.) Flow Characteristics: **Fast**
Deposits: ☒ None ☐ Mud ☐ Sludge ☐ Debris ☐ Grease
Silt Depth: (in.) Deposits Extent:
Infiltration: **None** Pipe Seal Cond: **Cracked**

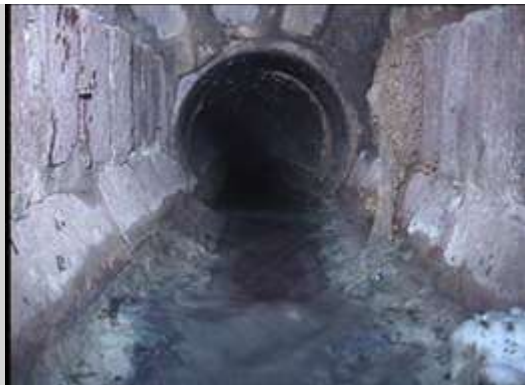
6 O'Clock Inflow

Pipe Height: **8.4** (in.) Rod and Bar (Angled)
Pipe Material: **Clay** ☐ Pipe Lined
Invert Depth: **12.08** (ft.) Flow Characteristics: **Fast**
Deposits: ☒ None ☐ Mud ☐ Sludge ☐ Debris ☐ Grease
Silt Depth: (in.) Deposits Extent:
Infiltration: **None** Pipe Seal Cond: **Cracked**
